# Manhole Inspection Summary

Manhole # S47A1\_005MH

Insp Date: **7/20/09 9:39 AM**

**Location** Address: **2101 E.Fort Ave.**

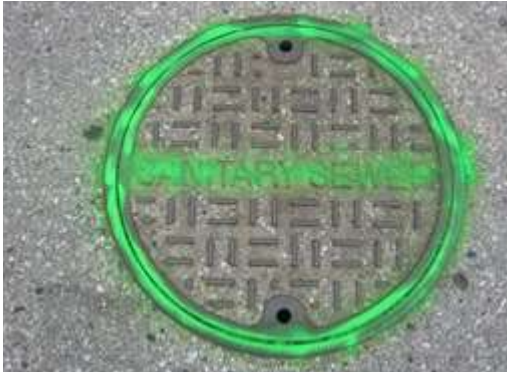
MH Cover

Condition: **Sound**

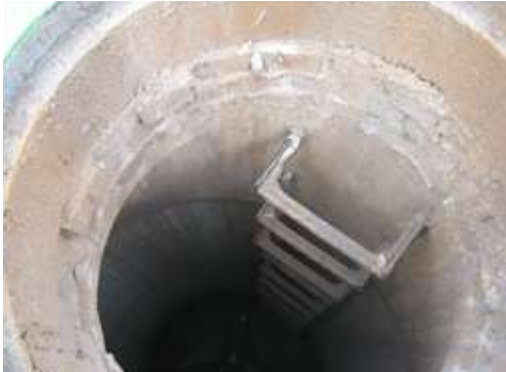
MH Steps

Count: **12** Missing: **0** ☐ Corroded

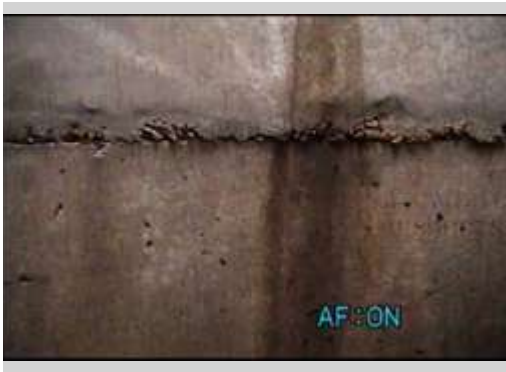
Defect 2

Infiltration: ☐ None ☒ **Joint** ☐ Cracks ☐ Mortar ☐ Roots ☐ Wall

infiltration at the corbel and barrel joint

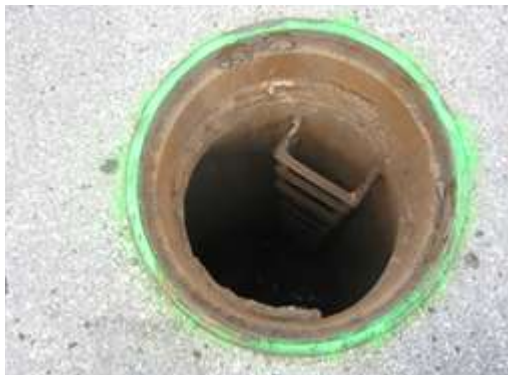
### Defect 1

Offset: **1** (in.)

frame offset

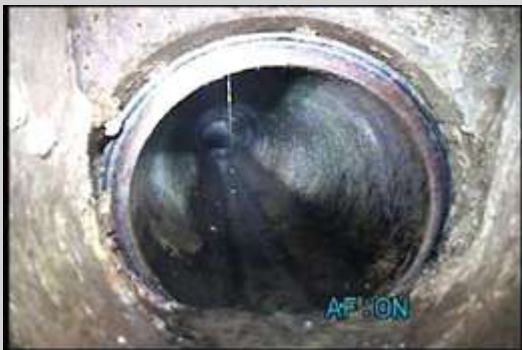
12 O'Clock Outflow

Pipe Height: **7.2** (in.) Rod and Bar (Angled)  
Pipe Material: **Clay** ☐ Pipe Lined  
Invert Depth: **14.84** (ft.) Flow Characteristics: **None**  
Deposits: ☒ None ☐ Mud ☐ Sludge ☐ Debris ☐ Grease  
Silt Depth: **0** (in.) Deposits Extent:  
Infiltration: **None** Pipe Seal Cond: **Sound**

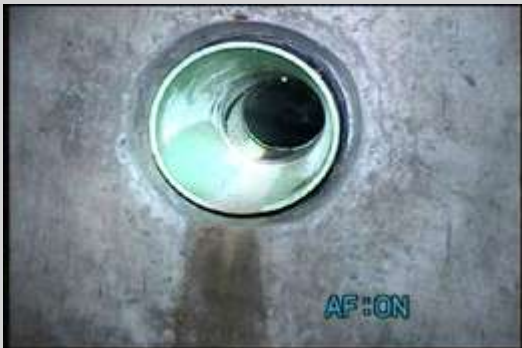
3 O'Clock Inflow

Pipe Height: **6** (in.) Rod and Bar (Angled)  
Pipe Material: **PVC** ☐ Pipe Lined  
Invert Depth: **10.44** (ft.) Flow Characteristics: **None**  
Deposits: ☒ None ☐ Mud ☐ Sludge ☐ Debris ☐ Grease  
Silt Depth: **0** (in.) Deposits Extent:  
Infiltration: **None** Pipe Seal Cond: **Sound**

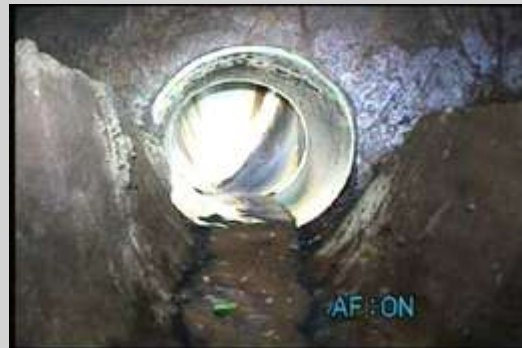
Drop In @ 3 O'Clock

Drop: **Outside** Rod and Bar  
Angled: **Yes** Reading: **13.20** (ft.)  
Inv Depth: **14.20** (ft.)  
Drop Condition: **Open**

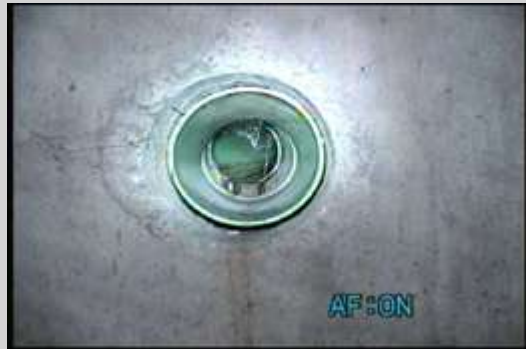
9 O'Clock Inflow

Pipe Height: **7.2** (in.) Rod and Bar (Angled)

Pipe Material: **PVC** ☐ Pipe Lined

Invert Depth: **10.50** (ft.) Flow Characteristics: **None**

Infiltration: **None**

Pipe Seal Cond: **Sound**

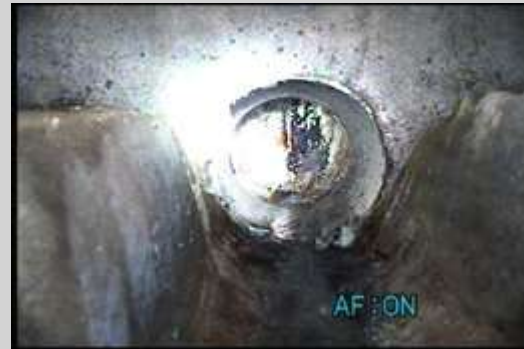
Drop In @ 9 O'Clock

Drop: **Outside** Rod and Bar

Angled: **Yes** Reading: **13.26** (ft.)

Inv Depth: **14.26** (ft.)

Drop Condition: **Open**
